DEPARTMENT OF TRANSPORTATION

Contract #: 04-0120F4Cty: SF/ALA Rte: 80 PM: 13.2/13.9File #: 69.28**WELDING INSPECTION REPORT****Resident Engineer:**Pursell, Gary**Address:** 333 Burma Road**City:** Oakland, CA 94607**Report No:** WIR-001622**Date Inspected:** 28-Feb-2008**Project Name:** SAS Superstructure**OSM Arrival Time:** 800**Prime Contractor:** American Bridge/Fluor Enterprises, a JV**OSM Departure Time:** 1730**Contractor:** Zhenhua Port Machinery Company, Ltd (ZPMC), Changxing Island **Location:** Shanghai, China**CWI Name:** Huang Wen Pang,**CWI Present:** Yes No**Inspected CWI report:** Yes No N/A**Rod Oven in Use:** Yes No N/A**Electrode to specification:** Yes No N/A**Weld Procedures Followed:** Yes No N/A**Qualified Welders:** Yes No N/A**Verified Joint Fit-up:** Yes No N/A**Approved Drawings:** Yes No N/A**Approved WPS:** Yes No N/A**Delayed / Cancelled:** Yes No N/A**Bridge No:** 34-0006**Component:** Plate Material Verification/Check Samples/flow**Summary of Items Observed:**

WELDING INSPECTION REPORT

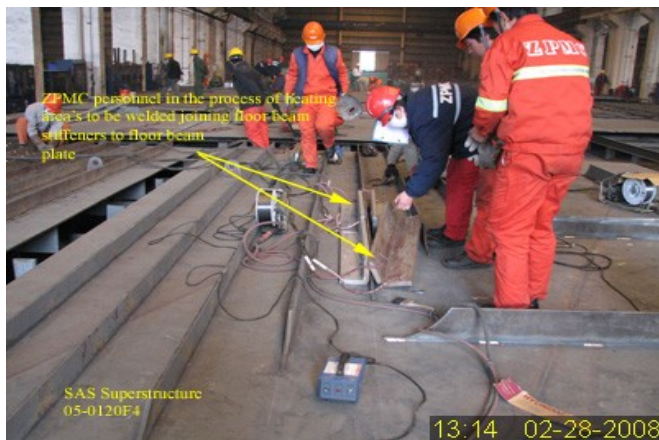
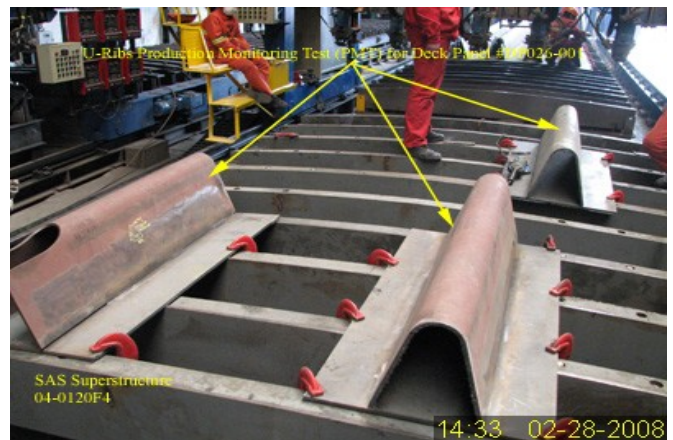
QA Inspector Brannon observed the 3rd U-Ribs Production Monitoring Test (PMT) for the (GMAW & SAW) process. QA Inspector Brannon observed the (SAW) process for production deck panel DP026-001 welds 1, 2, 5 & 6 and DP030-001 welds 1, 2, 3 & 4 closed rib welds. ZPMC welding personnel performed machine gas metal arc (GMAW) for the root pass and submerged arc welding (SAW) for the cover pass. Dual process WPS-B-T-2342-U1(U-rib)-3 was posted as the welding procedure specification for closed rib welding. The following weld joint and welder were recorded for the PMT, DP026-001 and DP030-001 weld joint (wj) wj-#1 Mr. Song Yin Shu ID#059421, wj-#2 Mr. Chen Jie ID#059468, wj-#3 Mr. Gao Xin Dong ID#059361, wj-#4 Mr. Jiang Ting Guang ID#062255, wj-#5 Mr. Mr. Song Yin Shu ID#0594 and wj-#6 Mr. Chen Jie ID#059468. Welding operator for the GMAW and SAW process was Mr. Li Xide. QA Inspector Brannon randomly observed ZPMC QC CWI Inspector Mr. Sun Wei monitoring welding parameters were in accordance with the Welding Procedure Specification (WPS).

The following digital photograph below illustrates observation of the activities being performed.
